Utility Structural Systems

November 15, 2005

Scope:

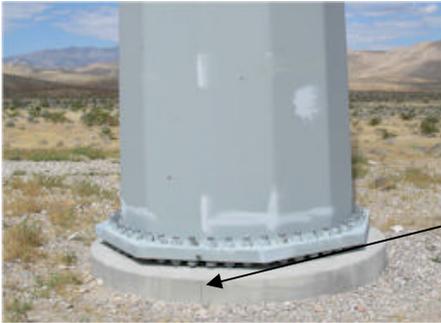
For comparison, we set up to test the structure we identified as the "base pole" which was a pre-cast concrete foundation with the pole bolted to the top of the foundation. The pole was not in direct contact with the soil so, according to construction personnel, it had a 10' x 3/4" ground rod placed in the annular space (although it appeared the ground rod was driven outside the hole given the proximity of the rod to the backfill).

Pole 1: This is a close up view of the initial pole used for base comparison. Note the location of the ground rod at the front base of the structure. Although the rod cannot be identified, the #6 solid copper wire connected to the rod is clearly visible.

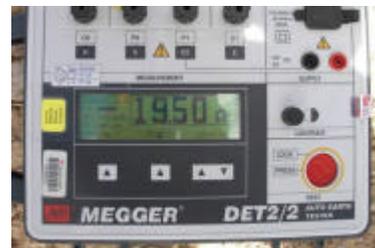
Pole 1: This is a close up view of the actual reading obtained on the above structure. The two red leads are attached to the grounding electrode itself, and the yellow lead is attached to a stake at 62' from the electrode and the blue is attached to a driven stake at 100'. The resistance reading was 19.50 ohms.

This reading was surprisingly lower than expected given the nature of the soil in desert southwest. The soils are generally not considered conductive due to the soil composition and the lack of annual rainfall. The average rainfall in the area is 1/2" per month.

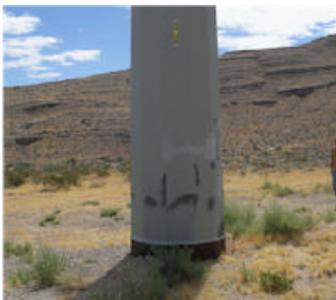
Pole 2: This is a close-up view of the second structure tested. It is a direct embedded pole set in concrete

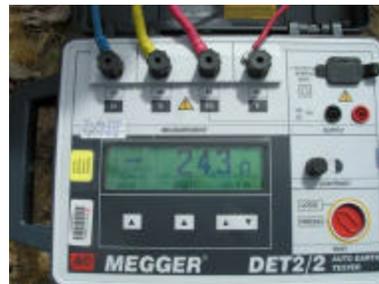
Pole 2: Normal, concrete backfilled pole with 10' x 3/4" copper ground rod. Reading is 24.3 ohms.

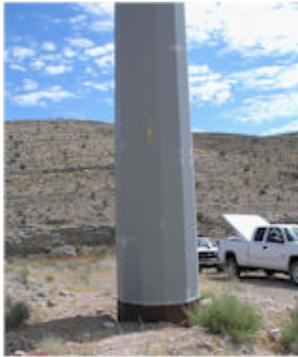
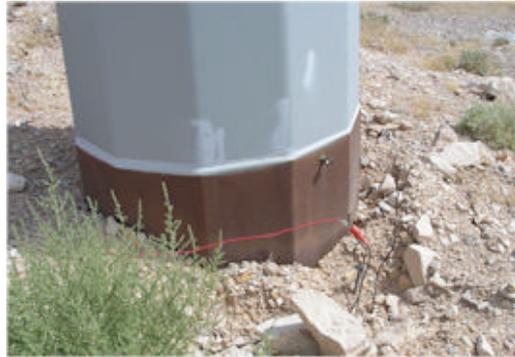
Pole 3: This particular pole had been post-installation retro-fitted with the above described steel plate backfilled with Poly-Ground[®]. It also had a driven rod that was installed during the initial installation.

I was told the reading was not as favorable as they thought it would be, so instead, the ground wire was connected to a ground rod installed during the initial installation. Both of the grounding electrodes in place on this pole were measured isolated and then tied together just to see the effect of combining the two. The readings shown on this structure show a slightly better reading on the ground rod versus the Poly-Ground[®] backfilled plate, but the results were even better when the ground rod and Poly-Ground[®] backfilled plate were tied together (see below).

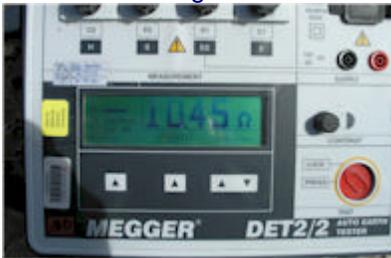
Reading #1

Pole 3: #1 is the ground rod isolated; reading= 10.45 ohms. #2 is the Poly-Ground backfilled plate isolated; reading=13.53 ohms. #3 is the copper rod and Poly-Ground plate tied together; reading= 8.68 ohms.

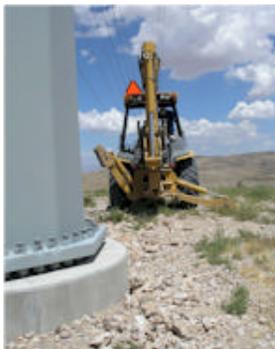
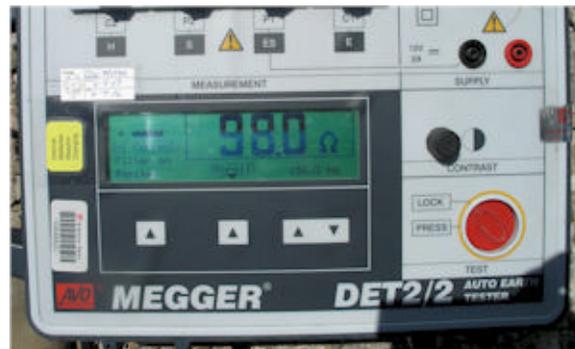
Pole 4: This structure was set on a pre-cast concrete foundation that had a galvanized plate put in the trench but was not treated with any backfill other than native earth. The plate was placed vertically in the trench and backfilled with the excavated material. The reading was 98.0 ohms.

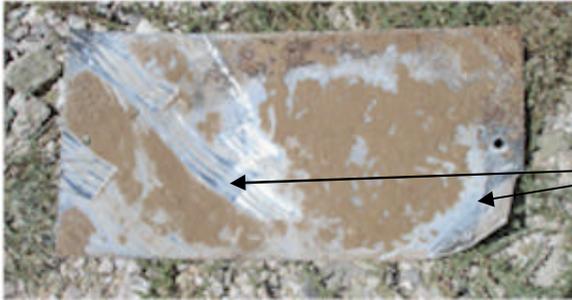
We decided to dig up the plate to check the connection and the condition since it had been in the ground since the July 2004 installation. During the excavation, we confirmed the idea that there was excess moisture located in the subsurface soil. The subsurface soil was very moist in nature and would "clump" together when squeezed. This was completely different than the soil present at the surface. This discovery was slightly disturbing but in all honesty, it was expected. The galvanized plate was dug up using the backhoe (in the above photo) and reviewed for connection and condition. It appeared to have been properly connected using Kearny clips. What was more disturbing was the condition of the plate after 13 months. It would explain the issue currently being discussed throughout the utility industry of the effects of corrosion on steel poles. See photos below:

This is the galvanized plate. The scrape marks are from the backhoe and the excavation process. The hole on the right hand side is where the copper wire was connected. The rust is visible all along the upper and right hand edges.

In this particular case, we decided to re-install a new plate matching the size of the excavated plate and reposition it horizontally and cover with Poly-Ground®. The trench was dug to a depth of about 24" and a width of almost 30". We did not intend to fill the entire trench, but enough Poly-Ground® was placed in the hole to be effective. One Poly-Ground® PG30W kit was poured in the trench and as the foam was expanding the plate was pressed into the foam to insure solid bond and contact with Poly-Ground®.

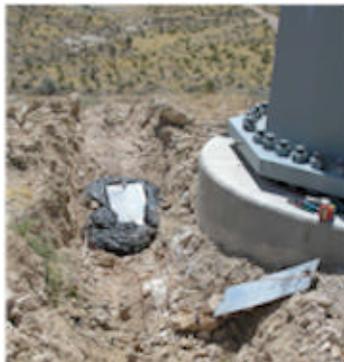
Pole 4: This is a photo showing the trench dug with a Poly-Ground® kit poured in the trench and the galvanized plate placed on top of the risina foam.

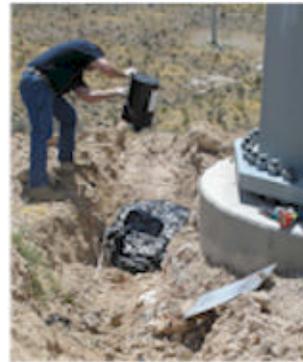
Pole 4: This photo shows a second kit being poured on top of the galvanized plate to insure maximum contact with the plate and to insure a water resistant seal to protect the plate from further degradation.

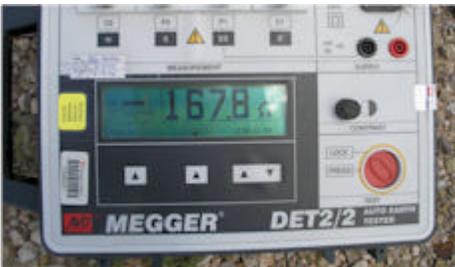
Pole 4: This is the reading of one plate encased in Poly-Ground®. It is important to note the only contact the plate/Poly-Ground® had with the ground was the bottom section as there are no sides and there is no backfill on the top. It is open air. The reading is 167.8 ohms.

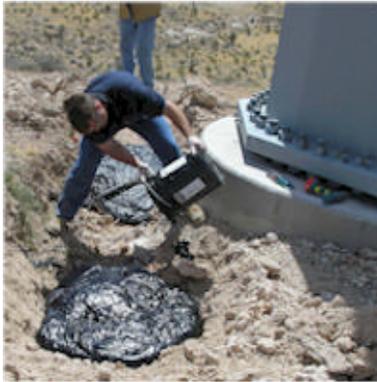
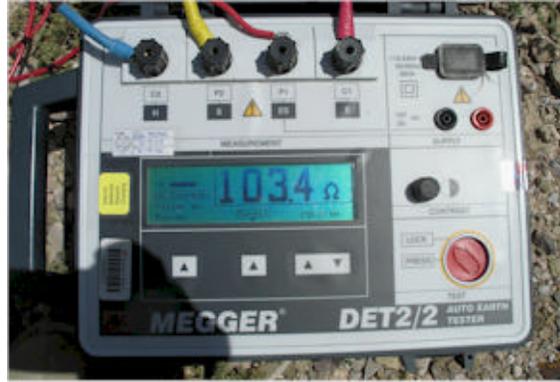
Pole 4: This photo shows the second installation and megger reading was 103.4 ohms. This reading is a cumulative reading of the first plate tied together with the second plate. So there are actually two plates tied together being read here, but there is still only bottom contact being made as the hole is still open air.

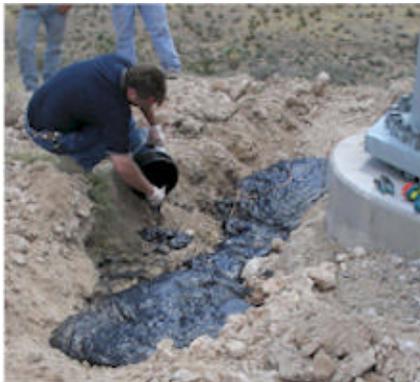
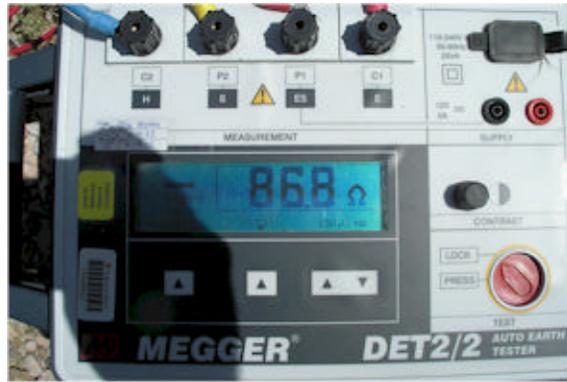
Pole 4: This photo shows the “connecting” of the two plates using a Poly-Ground® only connection and the subsequent reading, keeping in mind there is still only a bottom connection to the earth.

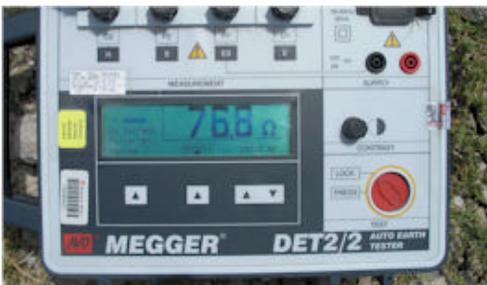
This is a photo showing the final reading of the two installed galvanized plates tied together in a single layer of Poly-Ground® after the trench had been backfilled with soil but not compacted. The final reading was 76.8 ohms.
