Utility Structural Systems

March 28, 2005

This test was an actual installation of Utility Structural Systems newest line of engineered backfills known as Poly-Ground[®]. In our opinion, Poly-Ground[®] has many benefits, such as worker safety and enhanced grounding, but perhaps one of the most significant benefits that can be noted is the lower impedance, which decreases line loss of the system. It also, in this particular case given this was a transmission line, provides a much more effective, safer, and faster path to ground for electrical discharges of all types.

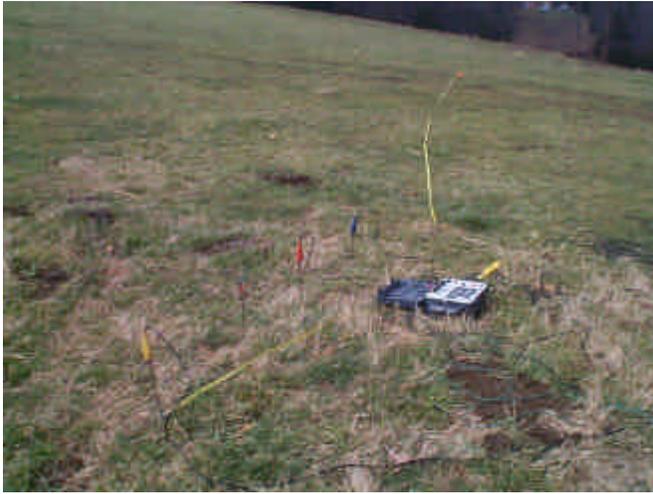
Appendix A Photos:

The poor soil condition readings obtained in this test (*see above chart*) means the soil in this general area was not particularly favorable to lowering resistance values. The resistance in this area ranged from 260 ohm-meter at 2' deep to 164 ohm-meter at 10' deep. I can only assume this was a known fact given this location was chosen to test our product. Once the clearance was obtained on the line, removal of structure 443 on this line was begun. Prior to excavation and removal of the north side structure, we were able to disconnect the ground line from the static line resulting in the southern pole on that structure being isolated from the rest of the poles and the system in general. This was done so we could tell exactly what readings were existed prior to the installation. Using the "Fall of Potential" method, a reading of 336 ohms was observed. This seemed high at first, but after reviewing the soil resistivity reading and plugging in the known data, it could be calculated that a 5/8" copper clad ground rod would have read about 79.2 ohms. This number was calculated using IEEE formulas and standards, and was not verified in the field. Once the north structure was removed from the hole, we viewed the remnants of the copper ground wire currently in place and massive corrosion had taken place. Corrosion was so prevalent, that the ground wire was actually in 3 separate pieces. At the end of the pieces, the ground wire was corroded to the approximate size of a pencil-point. It can be assumed this particular ground wire was highly ineffective in it current condition. It would also explain the extremely high reading obtained from the south structure. The poles being installed as replacements for the wood poles were poles supplied by Thomas & Betts Manufacturing from the South Carolina plant.

Line Traverse Method for Ground Resistance

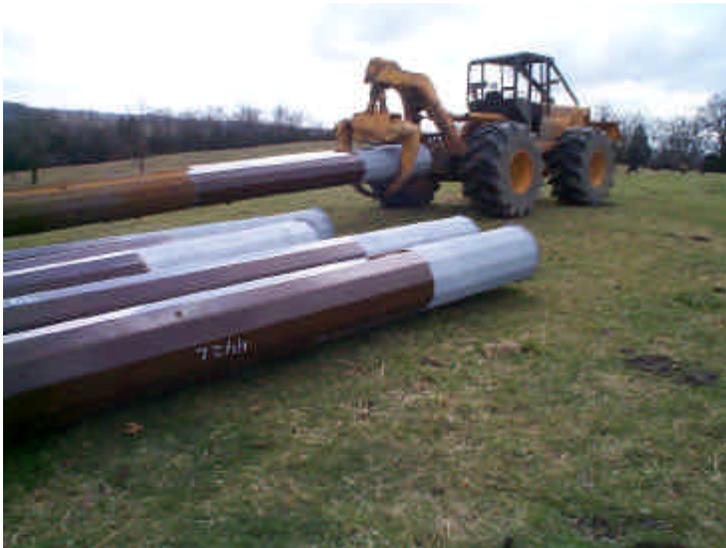
Appendix B Photos:

They were 2-piece Core 10, self-weathering steel poles with corro-coat (or similar product) applied from approximately 3' above grade to 4' above the butt of the pole. The 4' section of the pole was not coated in any way and appeared to have a galvanized finish. (*See Appendix "B" for a photo of the poles prior to installation*). The pole identification plate listed them as LD3 class poles 65' in height. These poles had a groundline diameter of about 15 1/2" with a butt diameter of 18". The hole was augered out to 26" in diameter to accommodate the new pole being installed. Once in place and plumb, the pole was then backfilled with 2 Poly-Ground[®] kits (PG-30W) and then finished off with a Poly-Set[®] kit (PS-250W). It was suggested by Utility Structural Systems, that the foundation be done this way as Poly-Ground[®] would not make a significant impact on the portion of the pole that was corro-coated because it could not make direct contact with that portion of the pole. We can presume the resistance numbers would have improved, but any improvement would have been negligible. Once set, this structure was not megged but the assumption could be made that the pole would have been relatively identical to the south structure. The south structure was removed in the same fashion and found to be in very close condition to the north structure. The ground wire on this pole was actually in 4 pieces. (*Please see Appendix "C" for a photo of the condition of the ground wire*). It was this structure that provided a reading of 336 ohms prior to removal, so it was decided that due to weather conditions, we leave the megger probes in place and meg this structure so to save some time in very inclement weather. It would also provide a direct correlation to what the readings were from what was existing to what reading was obtained showing the improvement from the new structure. The structure was backfilled in sections. The first reading obtained was after installing a single Poly-Ground[®] kit. That reading was 3.9 ohms. After the second Poly-Ground[®] kit was installed, a second reading of 4.19 ohms was taken. The reason for the increase is because the Poly-Ground[®] has an exothermic reaction (heat is generated) and heat is resistance. Once the foam cooled down the reading went back down to 3.87 ohms, showing virtually no gain resistance. The remainder of the structure was backfilled with Poly-Set[®]. Cross arms, X-braces and conductor/static installation completed the assembly of the structure and the job was deemed completed. (*See Appendix D for the finished structure*). I remained on site to answer questions from the crew, and staff. Poly-Ground[®] is similar in installation procedures to Poly-Set[®], however, Poly-Ground[®] MUST be pre-mixed with a drill and the combined foam must also be drill mixed given its much higher viscosity. The installation went well and I again thank all that attended.

Photo showing poles prior to installation

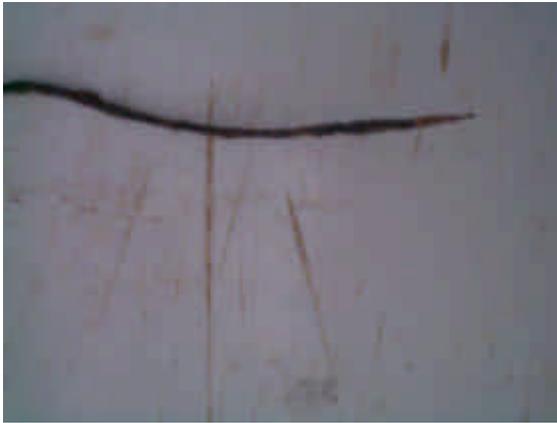
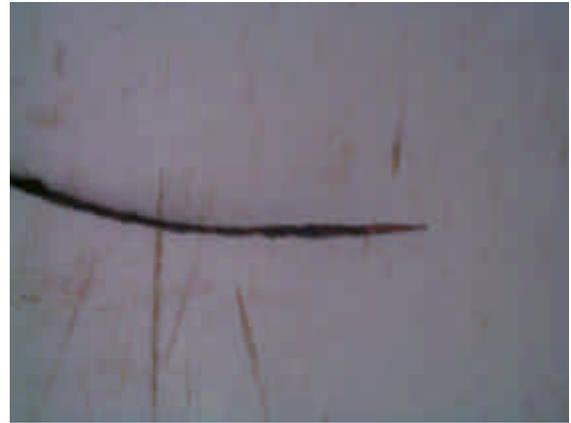
Appendix C Photos:

Photos showing the condition of the ground wire that was excavated from the existing structure. The ground wire from the ground line down, was corroded into 4 pieces.

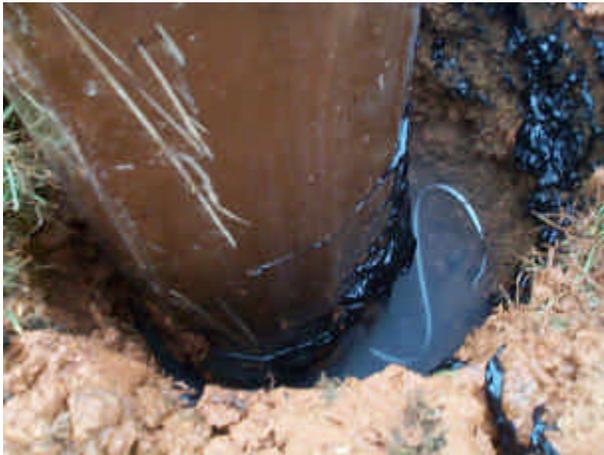
Appendix D Photos:

Photo showing Poly-Ground installed prior to Poly-Set backfilling
