January 26, 2005

This test was an actual installation of Utility Structural Systems newest line of engineered backfills known as Poly-Ground<sup>®</sup>. In our opinion, Poly-Ground<sup>®</sup> has many benefits, such as worker safety and enhanced grounding, but perhaps one of the most significant benefits that can be noted is the lower impedance, which decreases line loss, of the system.

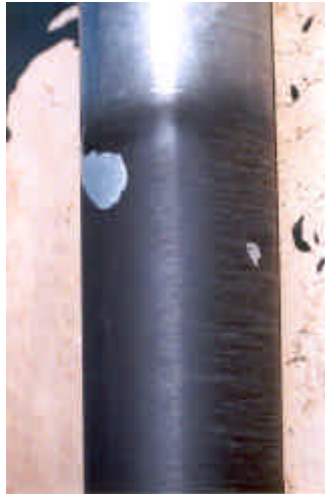
The wood H-Frames were being replaced with newer steel H-Frames identified as H1 class 70' poles. The majority of the embedded portions of these structures were coated with corro-coat but the bottom 2' was left galvanized. Upon examination of these structures, we were able to ascertain there was a problem with the corro-coat. It could not be determined at what point the damage actually occurred. This could have been an adherence problem, or it could just as easily been a pole handling issue. According to the people on site, this was not at all uncommon. What they were looking for was solid data leading to a possible solution of two independent problems they are encountering. The first problem is the resistance on transmission lines in areas where the soil is not beneficial to lowering impedance values. The second was the issue of corrosion on these specific structures throughout the majority of their system. Since Utility Structural Systems has a solution to both of these problems, it was decided the "hybrid foundation" be employed and evaluated. Utility Structural Systems newest product, Poly-Ground<sup>®</sup>, would be installed at the lower depths to cover the uncoated portion of the steel poles so to enhance the grounding thus, lowering the impedance value. The remainder of the void would be filled with Poly-Set<sup>®</sup> to add to the corro-coat, reinforcing any defects and adding several inches of protection. There were also several locations on the poles where large patches of corro-coat were completely missing. One area had about a 3"x18" strip completely missing that did not appear to have adhered at all.

Pole showing Corro-Coat issues
